Arecibo Science Advocacy Partnership

As many of you may have heard, the Arecibo Observatory suffered serious damage to one of its main support cables during the January 13 magnitude 6 earthquake. The damaged cable was the "short" cable delivered 12 feet too short by Bethlehem Steel in 1962 and then spliced so it could go into service at that time. The other cables retain sufficient strength to support the platform; however, should the damaged one give way, it would fall in a manner that would do severe damage to the reflector and its precise alignment.

During original AO construction, in 1962, one of the original 12 platform suspension cables was delivered too short, and a short cable section (12') was "spliced" to a 568' cable section running from tower T8 to the triangle corner — to provide sufficient reach to the platform. That cable segment and splice, near the top of one of the telescope towers, was consequently more rigid than the balance of the suspension system. When the earthquake shook the site, just after midnight on January 13, 2014, it is that short cable, and splice "box", that suffered damage. You might say that our structural Achilles heel was exposed.

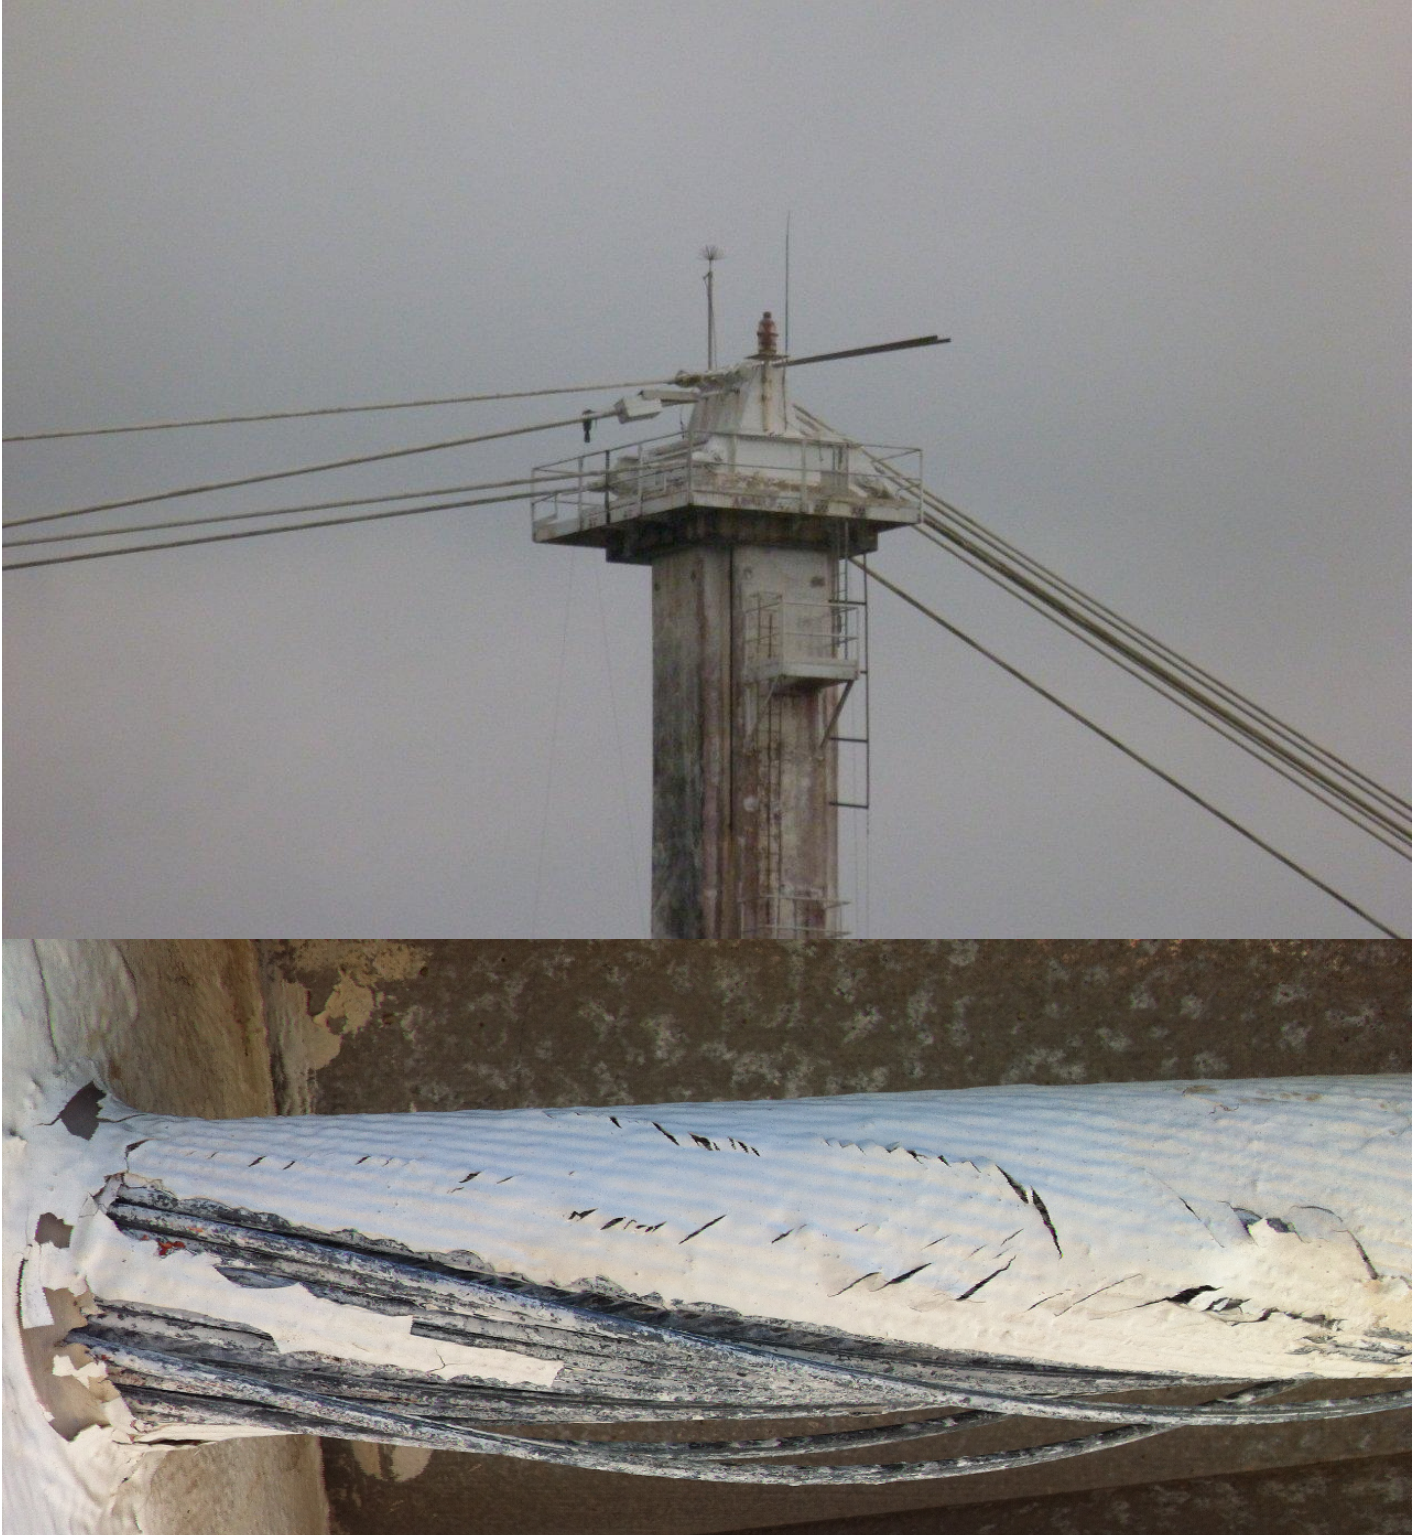
Project	ARECIBO OBSERVATORY BROKEN WIRE STUDY		
Description	ASSUMED DETAIL FOR SPLICE BOX		
Project No.		Date	1-21/14
Issue/Rev		By	JLS
File Name	SPLICE_BOX.DWG		
Scale	1 1/2"=1'-0"	Sketch No.	SK.01

A&W believe there was a significant "friction override" within the splice box, as the entire box was pivoted 15 degrees by consequence of quake motion. No one really knows what is inside that box, but A&W surmise it is arranged as in the drawing "SPLICE BOX.pdf" — with two "button sockets" on the end of each cable, fitted into the steel box. These button sockets are similar to those you can see at the end of cables in the saddle block. The photo "OVERALL EXTENSION CABLE 20110302.jpg" shows the button socket ends of the back-stay cables fitted into saddle block, as examples.
