Arecibo Science Advocacy Partnership

As many of you may have heard, the Arecibo Observatory suffered serious damage to one of its main support cables during the January 13 magnitude 6 earthquake. The damaged cable was the "short" cable delivered 12 feet too short by Bethlehem Steel in 1962 and then spliced so it could go into service at that time. The other cables retain sufficient strength to support the platform; however, should the damaged one give way, it would fall in a manner that would do severe damage to the reflector and its precise alignment.

During original AO construction, in 1962, one of the original 12 platform suspension cables was delivered too short, and a short cable section (12') was "spliced" to a 568' cable section running from tower T8 to the triangle corner — to provide sufficient reach to the platform. That cable segment and splice, near the top of one of the telescope towers, was consequently more rigid than the balance of the suspension system. When the earthquake shook the site, just after midnight on January 13, 2014, it is that short cable, and splice "box", that suffered damage. You might say that our structural Achilles heel was exposed.

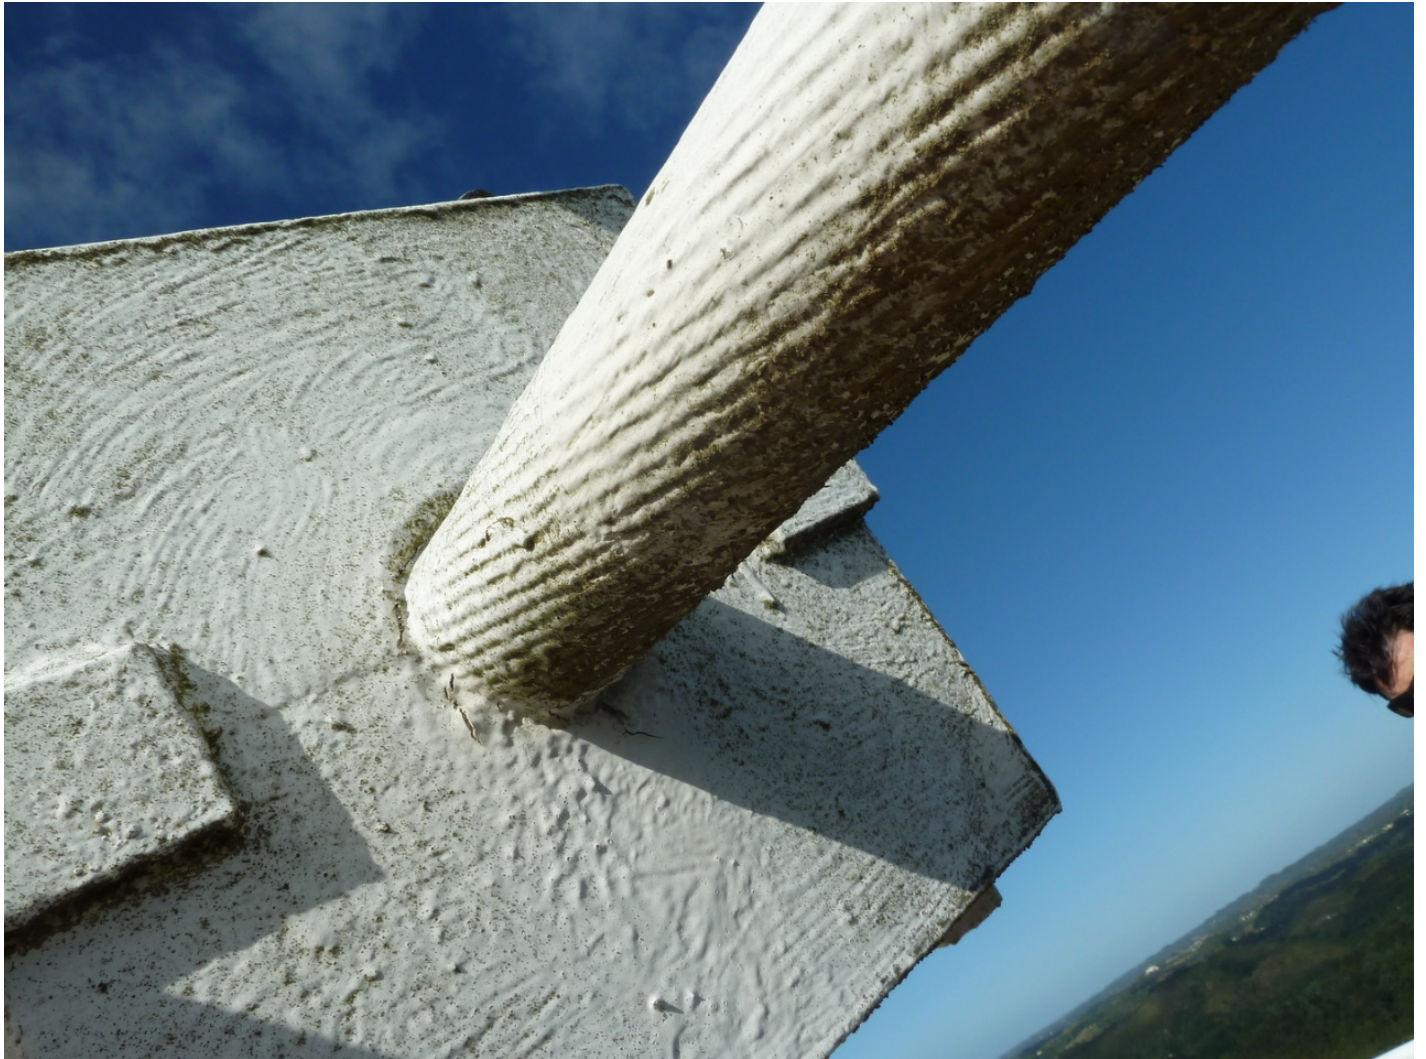
The photo "Tower 8 Top.jpg" shows the top of tower 8, post-quake. In this photo you can see the rectangular cuboid that is the "splice box".

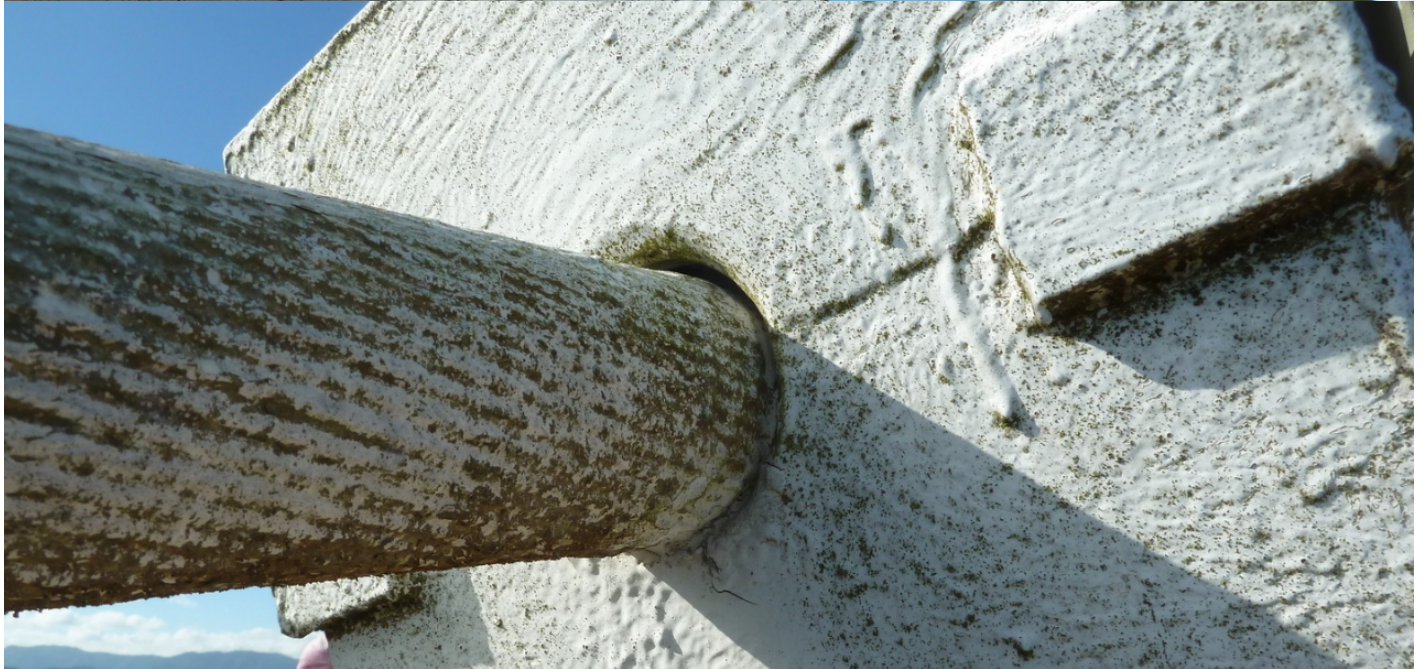
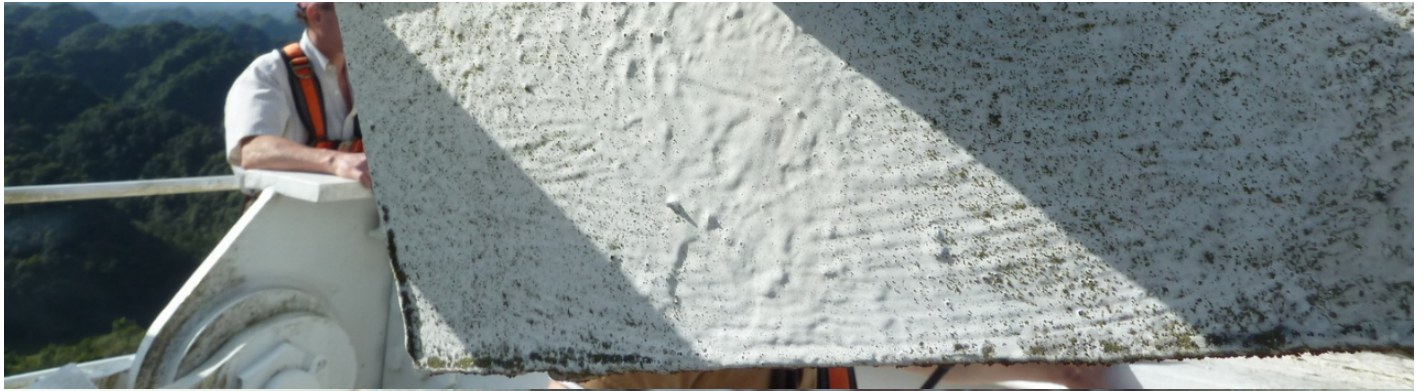
The photos "OVERALL EXTENSION CABLE 20110302.jpg" and "OVERALL EXTENSION CABLE 20140117.jpg" show the 12' extension cable pre-quake (03/02/11) and post-quake (01/17/14), respectively. (We had a structural survey performed in 2011 as a matter of structural stewardship.) Note the additional paint that was wrenched from the cable section, by quake motion — near the "saddle block" end of the cable.

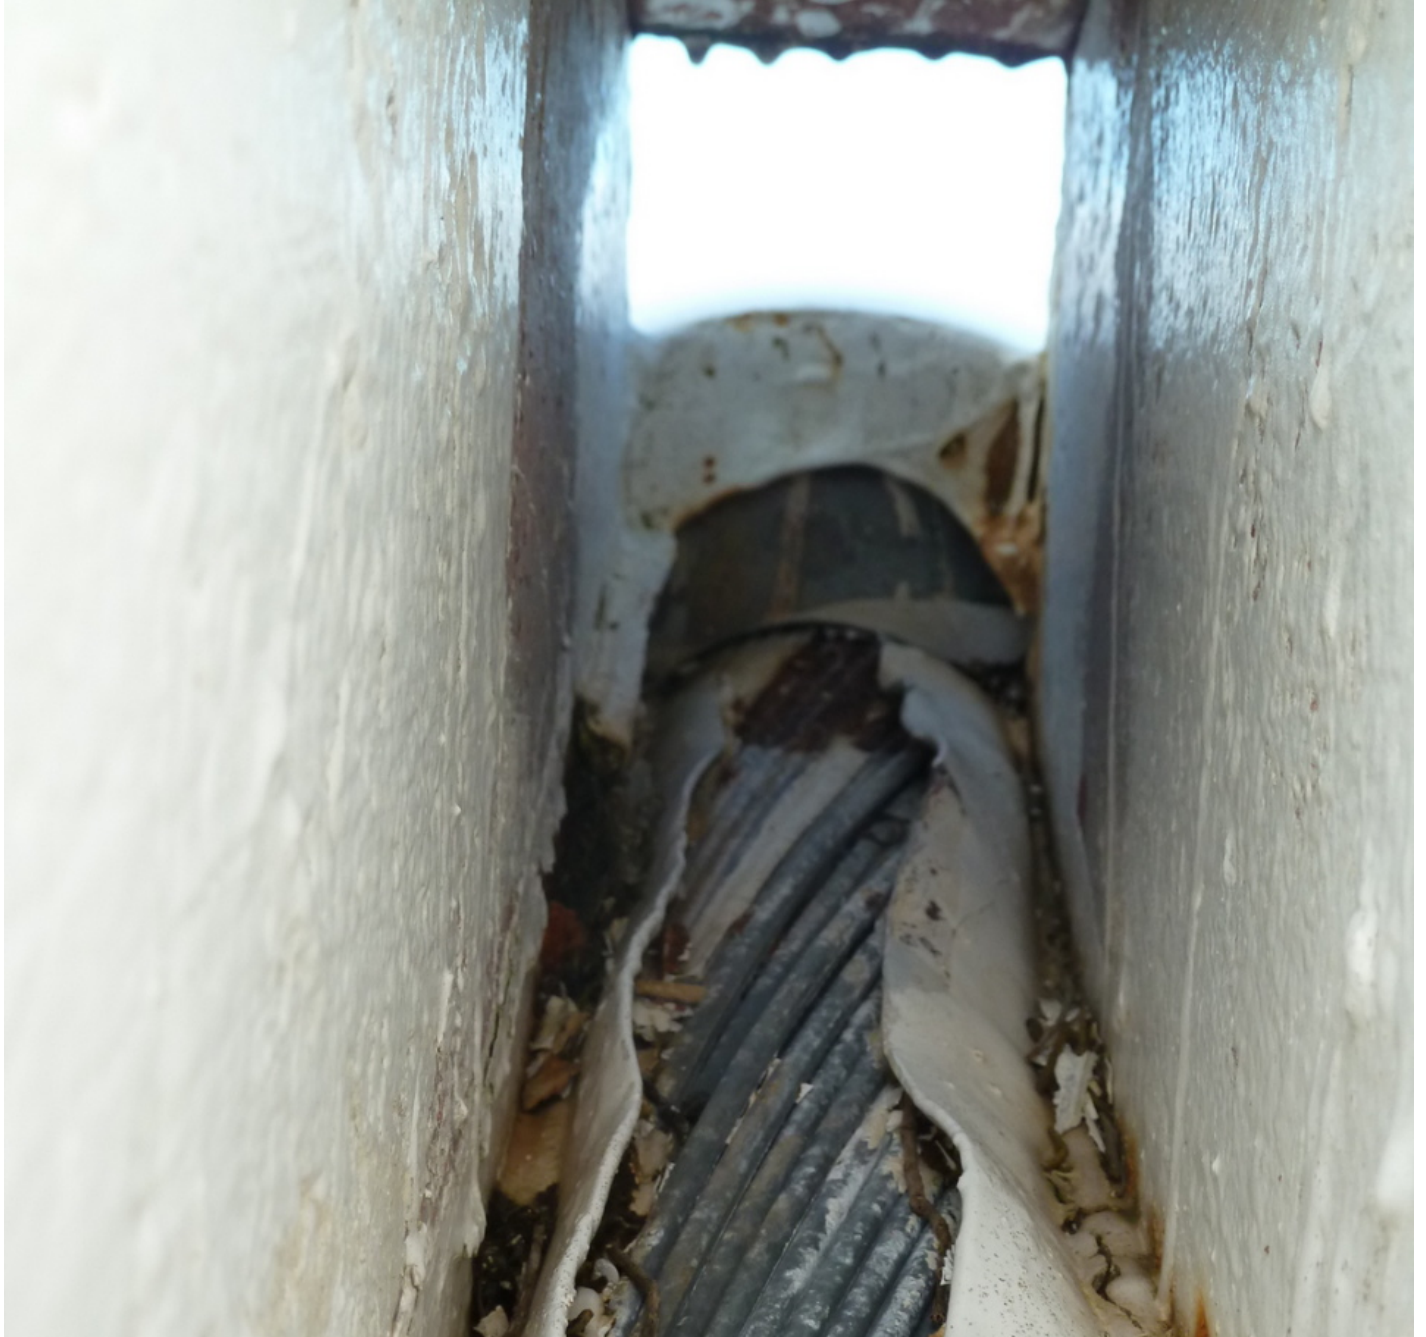
The photo "UPHILL Splice Box.jpg" shows the end of the 12' extension cable going into the splice box,

post quake. Note loose cable strands, likely broken.

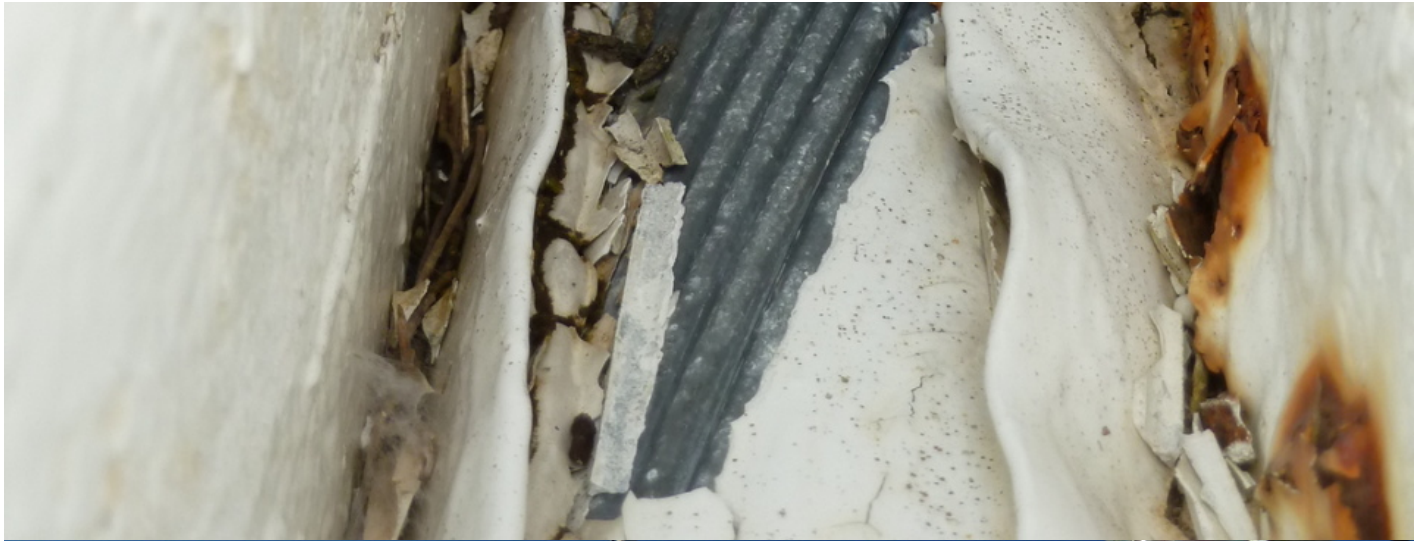
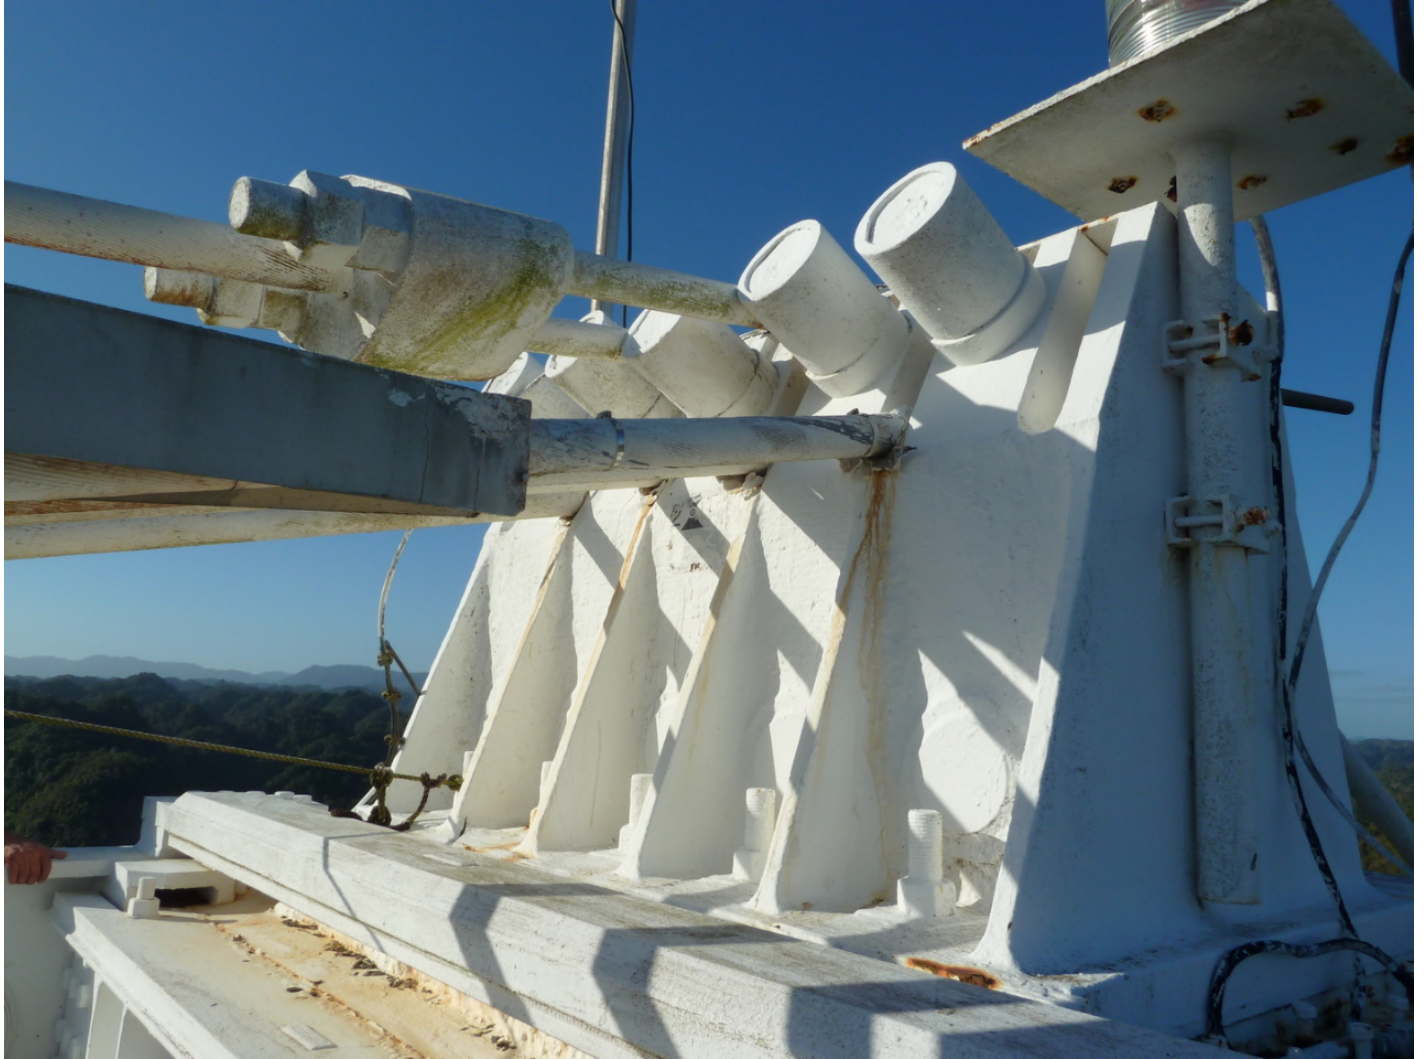
The two photos "DOWNHILL SPLICE BOX 1.jpg" and "DOWNHILL SPLICE BOX 2.jpg" show the splice box at the side where the 568' cable runs from the box on out to the platform - from two perspectives. No damage to cable strands on this side of the splice box, the platform side, is evident. Ammann & Whitney conclude that swaying motion in the long cable absorbed the energy of the quake motion, but that the shorter side of the cable arrangement, the extension cable, was more rigid, and more brittle, and thus the damage to the shorter, extension cable component.

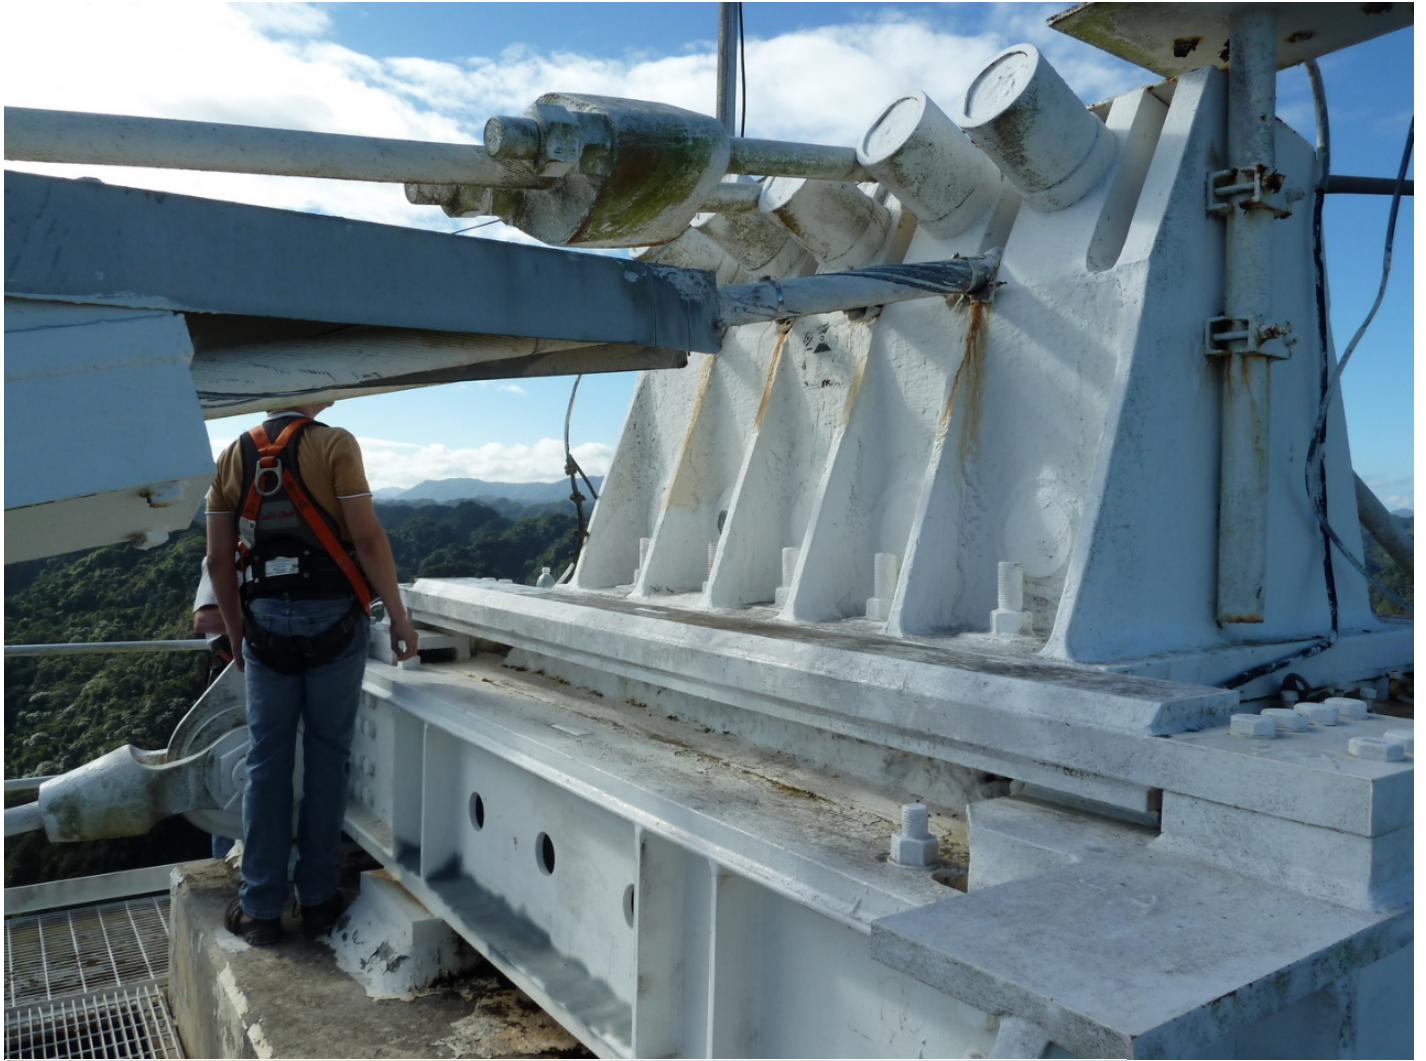
The photo "EXTENSION CABLE IN SADDLE.JPG" shows the end of the short, extension cable, within the saddle block atop the tower. At this end too, A&W believe there may be extensive damage to the cable strands, including internally, that cannot easily be assessed.

A&W believe there was a significant "friction override" within the splice box, as the entire box was pivoted 15 degrees by consequence of quake motion. No one really knows what is inside that box, but A&W surmise it is arranged as in the drawing "SPLICE BOX.pdf" — with two "button sockets" on the end of each cable, fitted into the steel box. These button sockets are similar to those you can see at the end of cables in the saddle block. The photo "OVERALL EXTENSION CABLE 20110302.jpg" shows the button socket ends of the back-stay cables fitted into saddle block, as examples.
